Aquatic Center Condition Summary

Summary

The Hood River Valley Parks & Recreation District recently contracted with Water Technologies Inc. (The largest aquatics engineering firm in the US) to conduct a condition assessment of the Hood River Aquatic Center. Their report concluded that the pool is past its usable lifespan. Key pieces of infrastructure are outdated or beginning to fail, and the effort and cost of maintaining the pool will soon exceed the cost of replacement. Barring any major complications, the pool has three to five years left of serviceable use.

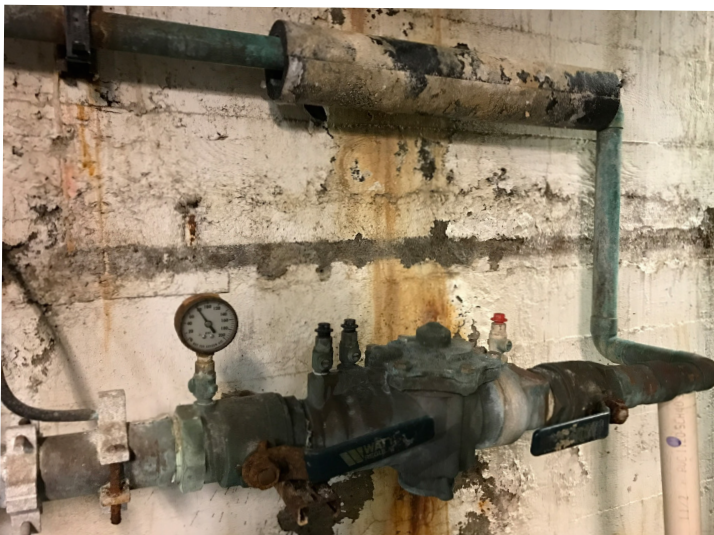
This deteriorating piping is a strong indicator of the condition of the thousands of feet of plumbing underground.

- The Aquatic Center's piping is from the original complex which was built in 1948. Not only is it nearly 70 years old, but it also no longer meets modern standards for water flow and pressure. Underground piping could fail at anytime which would result in immediate closure and costly repairs.

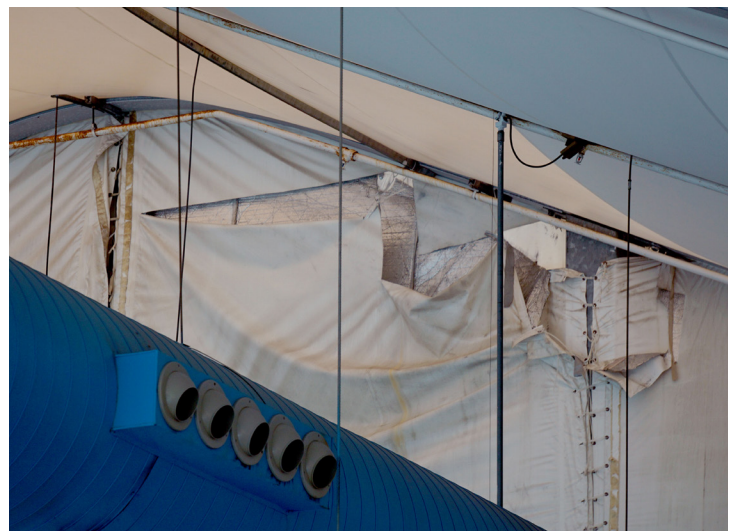
The tent wall on the west end is being held together by rope and zip ties.

- The tent enclosure is military surplus from the early 1990's which had a predicted lifespan of 20 years. The tent is going on 22 years. The tent has started deteriorating over the last decade and an average of 3 tent panels (approximately \$6,000 each) are being replaced per year due to wear and tear.

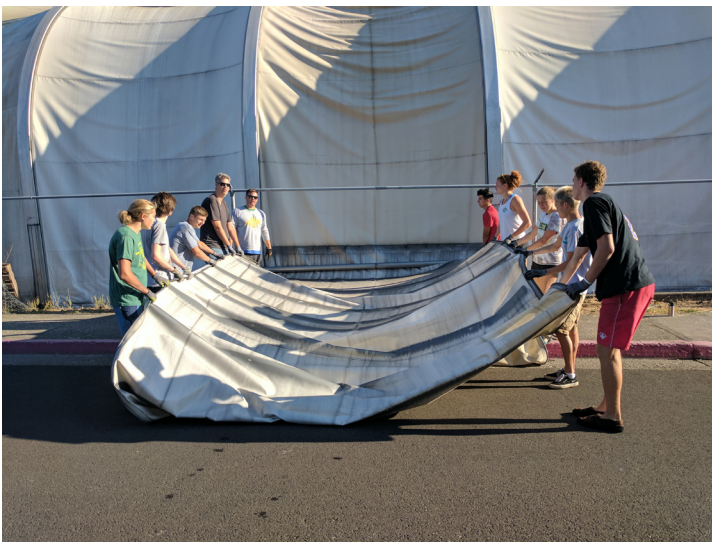
Panel replacements have become a common occurrence at the Hood River Aquatic Center.
